A World of Change

*1st Annual
AAR Research Review
November 6-9, 1995*

VOLUME 1: FAST/HAL TEST SUMMARIES

*Association of American Railroads
Transportation Technology Center
Pueblo, Colorado*

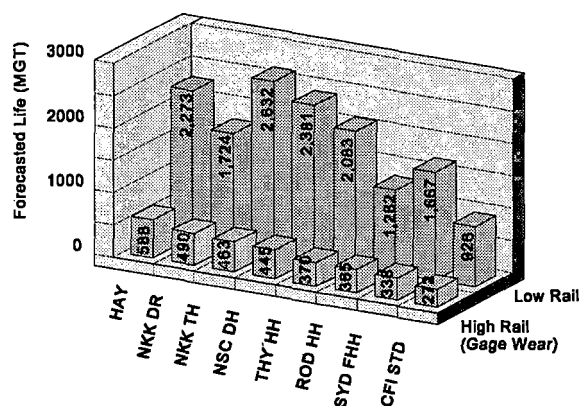
Figure 7. Forecasted Rail Life -- High and Low Rail

On the low rail, the control rail has a projected wear life of over 900 MGT and the NKK THH rail has a projected wear life of over 2,600 MGT. These long lives are likely due to operation of the FAST train overbalance speed and high lubrication levels of the low rail. These projected lives assume no fatigue failures will develop.

Forecast life results can be compared and contrasted with revenue service experience. On high rails, an outside observer might expect rail life to be lower in Section 07 since this curve is intentionally lubricated only lightly. However, lubrication conditions in revenue service often end up like those in Section 07. Rail grinding and hollow tread wheels also reduce high rail wear life in revenue service. On low rails in revenue service, there are areas where trains operate below balance speed and head height loss of the low rail is a critical issue. In such instances, low rails may be replaced at 2 to 3 times the rate of high rails, and high rails are often transposed to low rails because they have encountered substantial gage wear with minimal height loss. Other conditions that may accelerate low rail wear include poor lubrication, hollow tread wheels that increase contact stresses, and rail grinding which has been demonstrated to only increase wear rates. Table 2 summarizes the rail life comparisons between FAST and a typical revenue service curve and gives likely reasons for the similarities and/or differences.

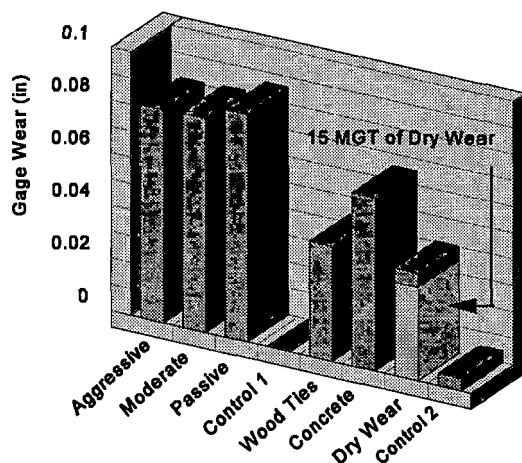
Figure 2. Total Gage Wear in Grinding Test Zones in 99.4 MGT

The amount of gage wear that occurred in 99.4 MGT listed in Table 1 is illustrated in Figure 2. The three grind zones in Section 25 (aggressive, moderate, and passive) all have the same amount of gage wear even though

The rails that are ground to similar profiles as those in Section 25 (Wood and Concrete Zones in Section 3) and then allowed to wear to the shape of the wheels have a lower wear rate. The initial gage relief in these zones is nearly gone when the rails are re-profiled every 50 MGT. Finally, those rails that are not ground (Control Zones and the Dry Wear Zone) have extremely low gage wear rates. Essentially, no gage face has developed in the Control Zones, and the Dry Wear Zone gage face developed during the initial 15 MGT of dry wear. These observations indicate that profiling a high rail of a curve with gage relief

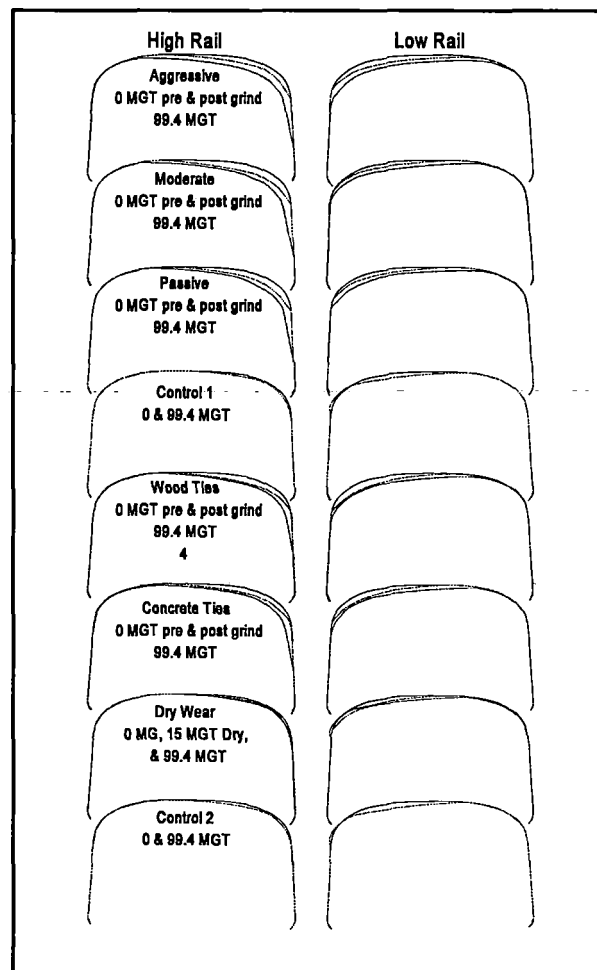
Figure 3. Profiles of Test Zones at 0 MGT and 99.4 MGT

Appreciable metal must be removed to establish a worn profile shape on new rail in the high side of a curve and to recrown the low side of the curve with center of rail contact. This amount is illustrated in Figure 3 which shows rail profiles of all test zones at 0 MGT, after being ground at 0 MGT (in the

grind zones), and at 99.4 MGT. This figure also illustrates the overall wear that accumulated in each zone to date. Much of the overall wear during the first 100 MGT of the rail's life can be attributed to the first grind. Figures 4 and 5 illustrate the source of vertical wear on the high and low rails, respectively. Both the amount of rail ground off during the grind maintenance intervals and the amount of rail to wear naturally throughout the test are shown. Though the numbers are not included, nearly all the grinding wear illustrated came at the first grind interval when the high rail was ground to the worn profile shape, and the low rail was re-profiled to either an 8- or 5-inch crown radius.

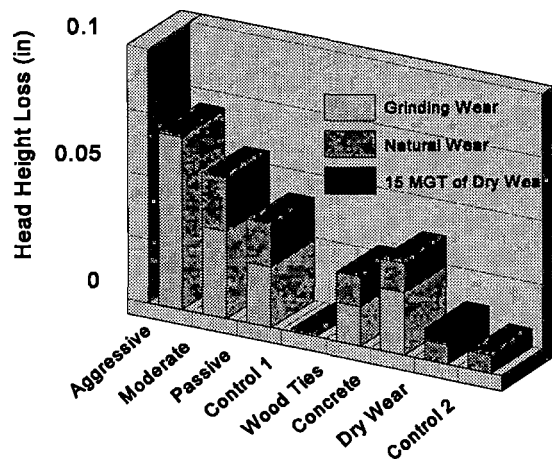
Figure 4. Head Height Loss of High Rails in 99.4 MGT

Figures 4 and 5 also show that natural wear rates (not including metal removed by grinding) are increased by grinding. Compared to the ground rails, the control rails and the dry worn rails had lower natural vertical wear rates on both the high rail and low rail. This may be for several reasons; e.g., the work hardened surface layer, which is very resistant to wear, is preserved on the

non-ground rails; contact stresses are increased and bearing surface decreased on profiles ground to other than a naturally worn profile; and truck curving forces are minimized with non-ground profiles, or with ground profiles identical to naturally worn profiles.

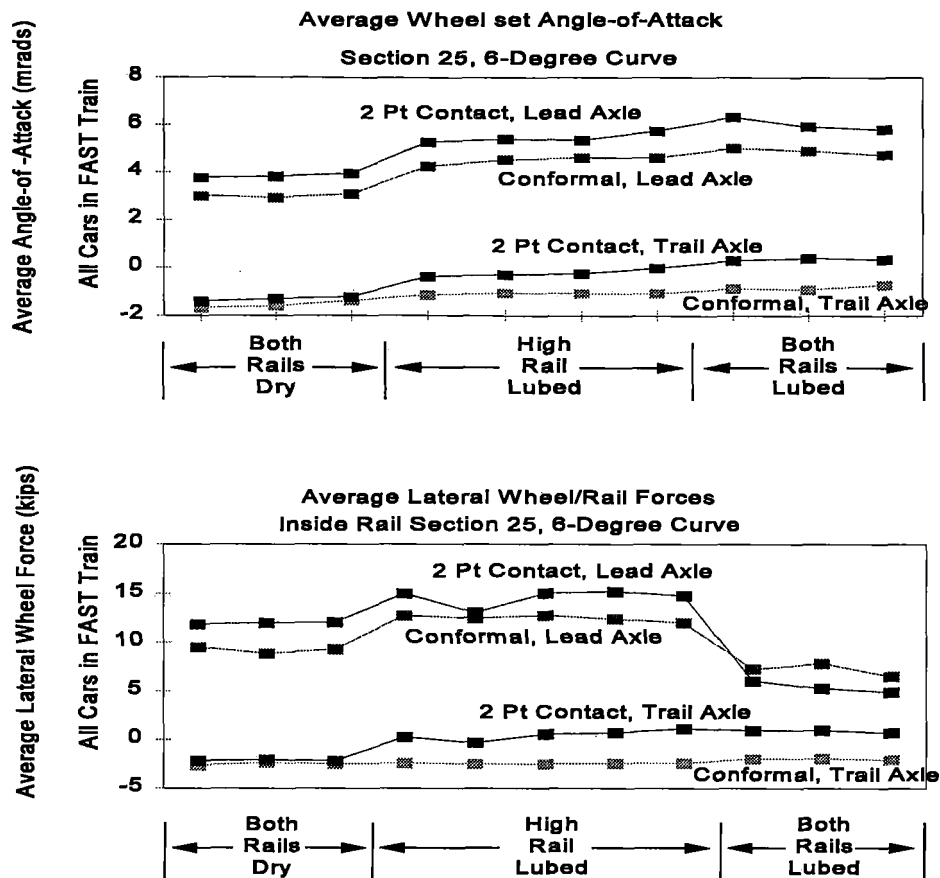
Figure 6. Angle-of-Attack and Lateral Forces before (Conformal) and after (2 point contact) High Rail Gage Corner Relief Grinding

Subsequent to grinding, average angle of attack for both lead and trail axles of the FAST consist increased by about 1 mrad under almost all lubrication conditions. This indicates that less positive steering forces were being provided by the wheel sets due to high rail gage corner relief. In the exception condition, both rails were dry, and similar steering forces were being produced after grinding due to the dry flanging. Interesting to note is that the angle-of-attack rose after both rails were lubricated, though at the same time the lateral forces dropped appreciably for the lead axles.

Lateral forces, which are in part a function of low rail lubrication conditions, were highest when the low rail was dry. Under this condition, the ground profile lateral wheel forces always exceeded the non-ground forces, usually by about 2,500 pounds (or a truck side increase of 5,000 lbs). The worst condition was when the high rail gage face was lubricated, the low rail was dry, and the rail had been ground. In fact, at a time when lead axle lateral forces were highest, this condition brought positive forces from the trail axles (on average) which now contributed to gage widening. Before, the trail axles curbed gage widening. Lubricating both rails brought forces down

and is the approach often taken in revenue service to control forces, especially where two point contact grinding is used. However, this can be viewed as a "Band-Aid" approach because the wheel set angle-of-attacks are highest under this approach and it will likely cause the most truck wear.

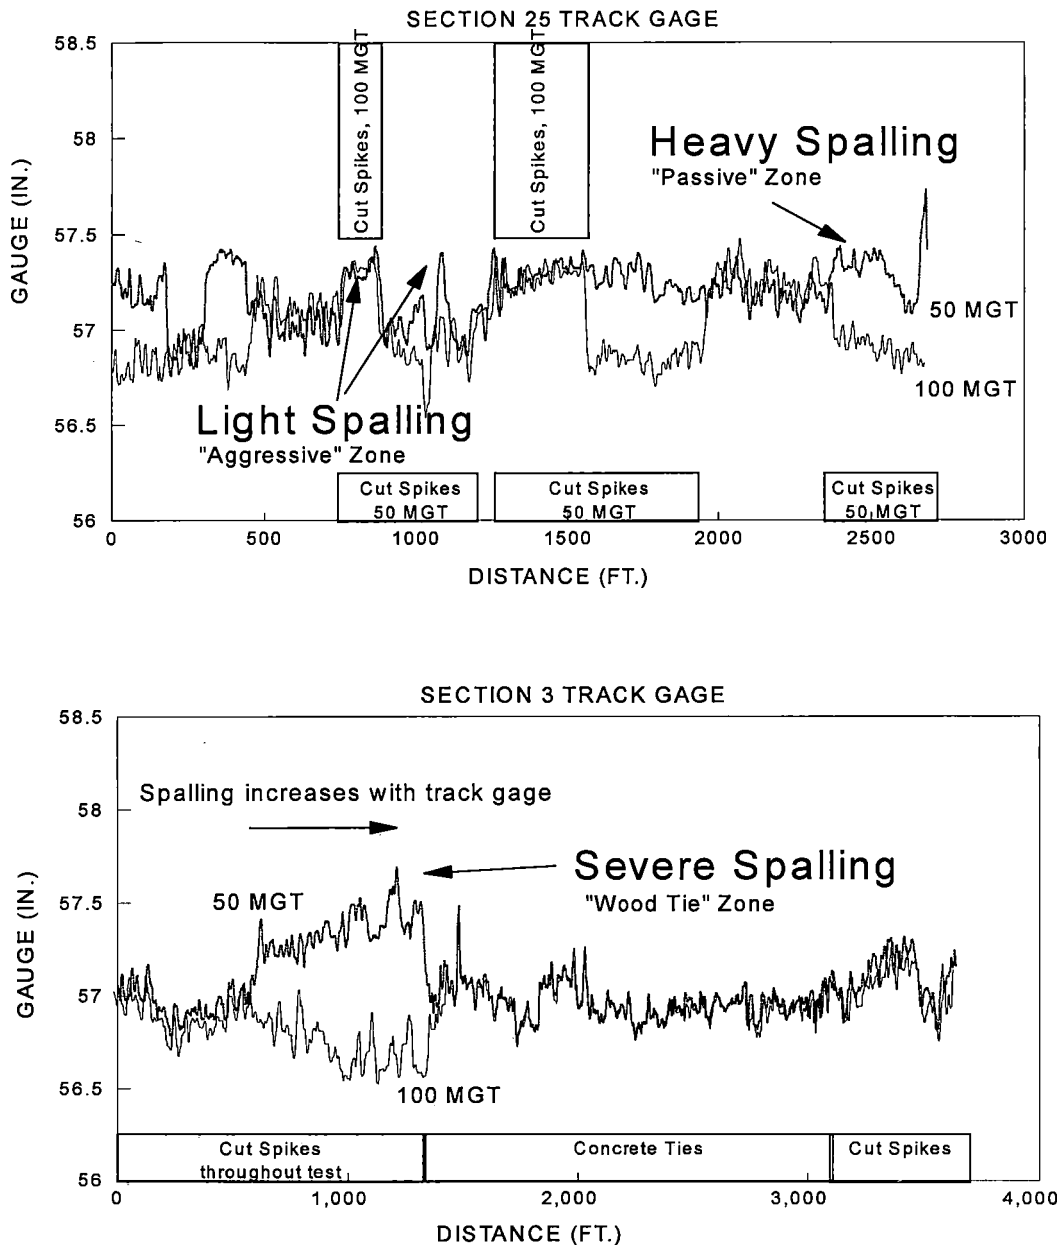
Figure 7. Track Gage in Test Sections and Spalled Rail Locations

Low rail spalling has developed in three areas of the test originally with cut spike track and wide gage: (1) severe spalling developed on the low rail of the Wood Tie Zone in Section 3 by 50 MGT, (2) spalling developed at the end

of Section 25 in the passive zone and was heavy by 50 MGT, (3) light spalling developed in the Aggressive Zone and is not yet a concern. Gage measurement results at 50 MGT and 100 MGT for Sections 25 and 03 are illustrated in Figure 7 along with arrows marking the location of the spalled rail. Since

the curves are a mixture of ties and fasteners, the cut spike zones are shown. Section 25, all wood ties, had three cut spike zones at 50 MGT that have been reduced and/or eliminated. Section 03 contains only cut spikes and concrete ties with elastic fasteners as illustrated.

The severe spalling in Section 03, illustrated in Figures 8 and 9, developed under excessively wide gage conditions of 57.5 inches. Though wheels at FAST are not known to be hollow, the natural convex shape at the rim of the wheel was riding directly on top of the 5-inch crown low rail (and directly over the spalls) as shown in Figure 10. When the Wood Tie Zone was regaged at approximately 55 MGT, only three of the 11 rails had spalled. However, the

damage was apparently done. By 100 MGT, the spalling extended to all but two of the rails in the zone. It is worth noting that the spalling cannot be solely blamed on the 5-inch crown as the Concrete Tie Zone also has a 5-inch crown low rail and is exhibiting no spalling. Also after regaging and without any non-scheduled grinding, the spalling in the Wood Tie Zone appears to be less severe in the original three rails at 100 MGT than it did at 50 MGT.

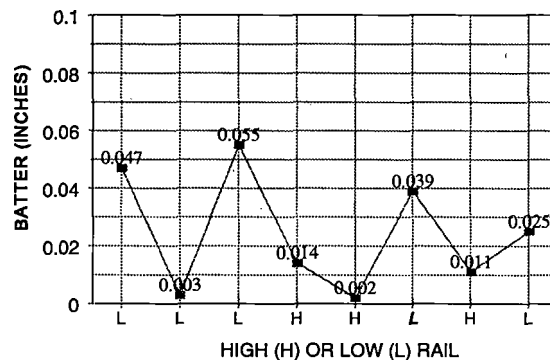
Figure 2. Standard Thermite Welds Showing Amount of Batter After 59 MGT

premium thermite welds. This decrease can be largely attributed to the higher hardness of premium welds. Comparisons made between test welds in track, after 72 MGT of traffic, show that, on the average, the premium welds displayed a 24-percent higher resistance to batter than did the standard welds. Figures 2 and 3 show a comparison between eight standard and eight premium welds along with the effect from batter since the last grind. As shown in Figure 2, the high rail welds displayed a lower effect from batter. And in Figure 3 the effect from batter appears to be more consistent with premium welds.

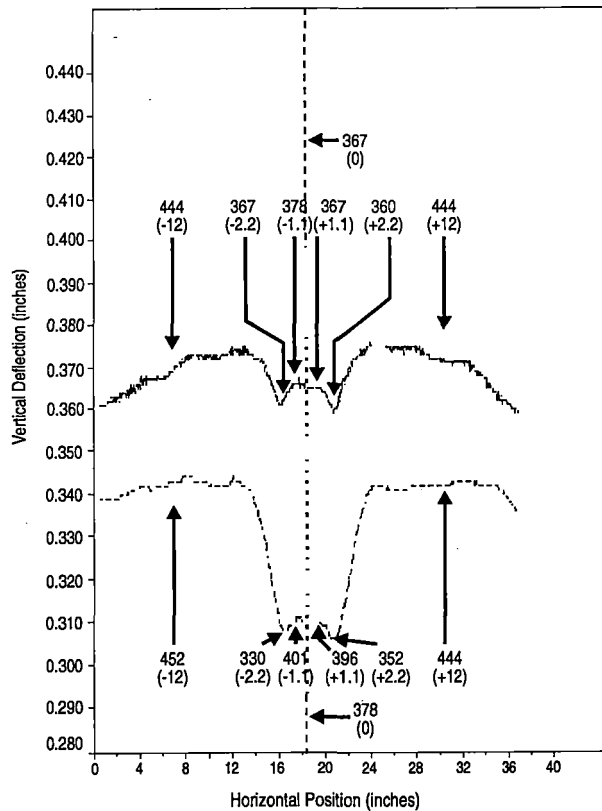
Figure 4. LRP's and Bhn's on a Standard Thermite Weld which was Air Quenched

The weld represented in Figure 4 is a standard weld with a standard mold which was air quenched. This particular weld can be summarized as follows:

- ▶ The weld was placed in track on August 14, 1992.
- ▶ The weld has accumulated approximately 74 MGT of heavy axle load traffic.
- ▶ The amount of batter incurred since the last grind is 0.055 inch after 59 MGT of traffic.
- ▶ The batter displayed can be classified as that of a double dipper configuration.
- ▶ The surface hardness at installation was 340 Bhn.
- ▶ The post grind surface hardness was 367 Bhn and

- ▶ The current surface hardness measures 378 Bhn.

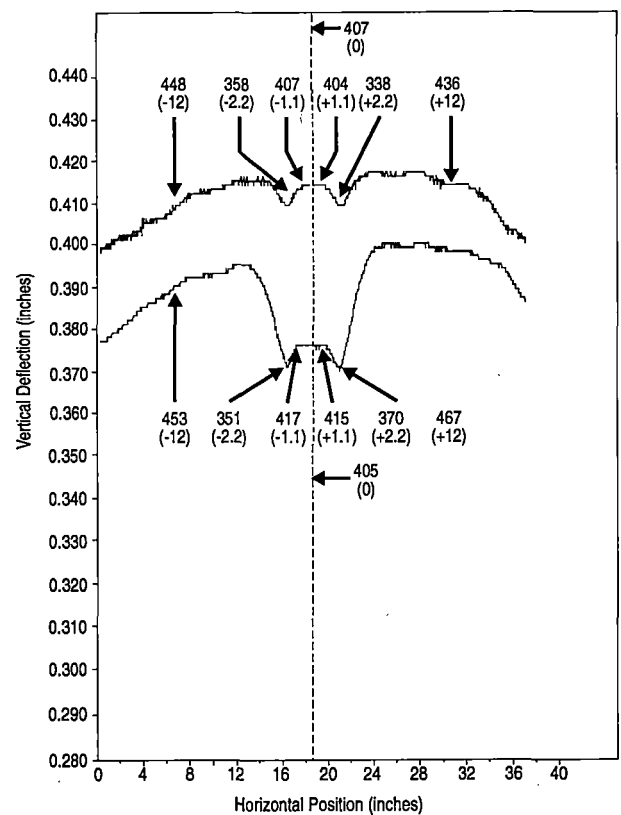
Figure 5. LRP's and Bhn's on a Premium Thermite Weld

The weld represented in Figure 5 is a premium weld with a standard mold. This particular weld can be summarized as follows:

- ▶ The weld was placed in track on August 19, 1992.
- ▶ The weld has accumulated approximately 76 MGT of traffic.
- ▶ The amount of batter incurred since the last grind is 0.038 inch after 59 MGT of traffic.
- ▶ The batter displayed can be classified as that of a double dipper configuration.
- ▶ The surface hardness at installation was 364 Bhn.
- ▶ The post grind surface hardness was 407 Bhn and
- ▶ The current surface hardness measures 405 Bhn.

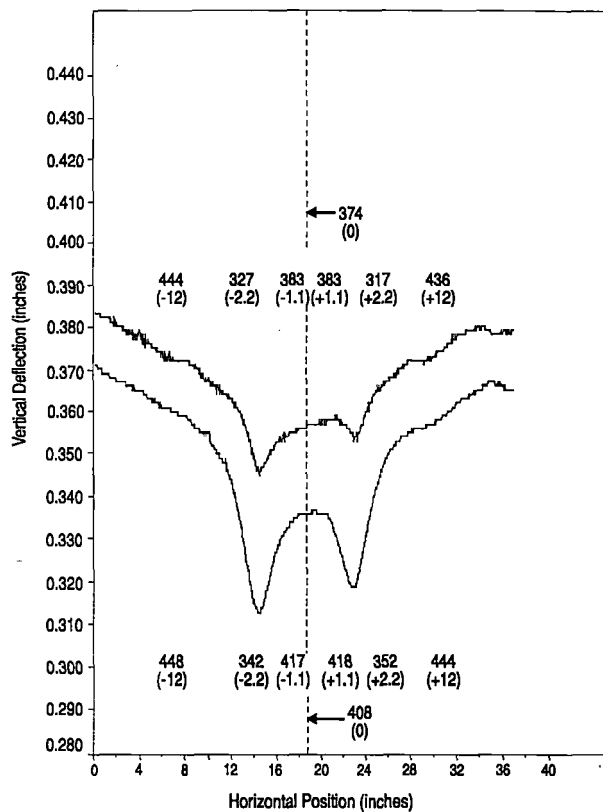
Figure 6. LRP's and Bhn's of an Ultra-Premium Thermite Weld (380+Bhn)

The weld represented in Figure 6 is an ultra-premium weld with a standard mold. This particular weld can be summarized as follows:

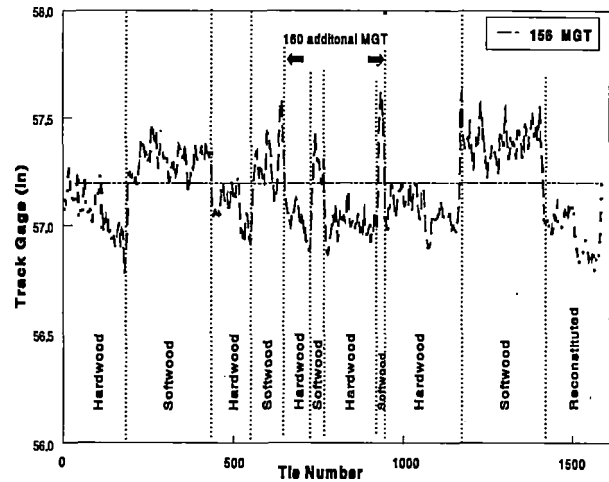
Figure 3. Measured Track Gage Using the EM80 Geometry in Section 25

Figure 3 shows the track gage measured using the EM80 geometry throughout Section 25. The figure shows that all of the softwood species have gage widened more rapidly than the hardwoods. Track gage for all of the softwoods falls above the horizontal line. The reconstituted ties at the end of the section did not gage widen as rapidly as the other ties installed at the same time. However, because of rail seat cracking, they were removed from track.

With an additional 160 MGT of HAL traffic, the Douglas fir and oak ties shown in the center of Figure 3 show less or about the same gage widening as the other hard and softwood ties. The Douglas fir in this section

required re-gaging after 360 MGT of HAL traffic. However, the Douglas fir ties in Section 07, which had accumulated the same amount of tonnage, required no maintenance.

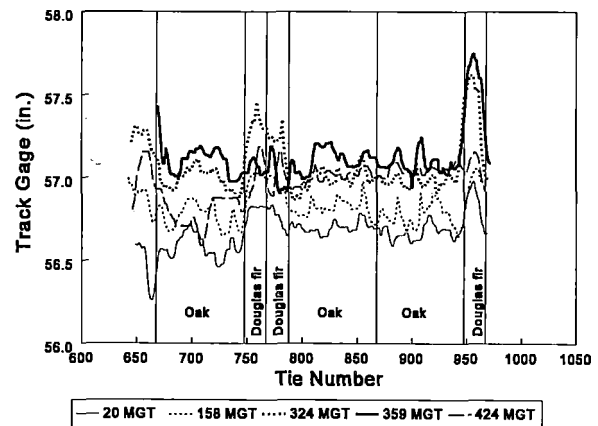
Figure 4. Measured Track Gage in Section 25 for Douglas Fir and Oak Ties

Figure 4 shows track gage measured only on the Douglas fir and oak ties. The data shown reflects 424 MGT of accumulated HAL traffic. The two middle sections of Douglas fir ties, which are shown as a solid line on the plot, were re-gaged after 359 MGT of HAL traffic and retrofitted with Pandrol plates and coach screws. The Douglas fir tie section on the far right was re-gaged at 375 MGT and the cut spikes were retained. No change in gage widening between the two sections was noticeable at 424 MGT.

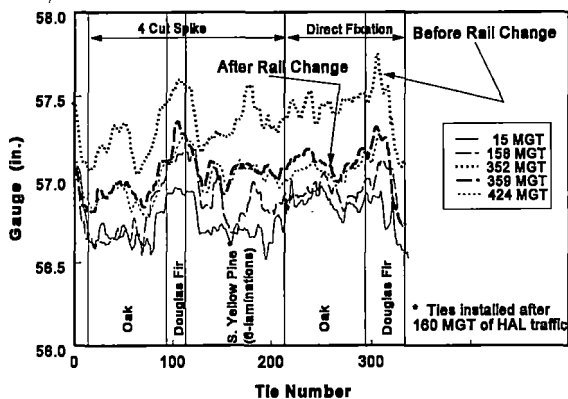
Figure 5. Gage in Section 07 -- Douglas Fir and Oak Ties Test Areas

Figure 5 shows the measured track gage on the Douglas fir and oak ties in Section 07. The highest measured gage is about the same for both Sections 07 and 25; however, about ½ inch of the measured gage in Section 07 is due to rail wear. When comparing measurements at 352 and 359 MGT, the extent of rail wear in Section 07 is noticeable. The rail was changed just prior to the 359 MGT measurement. Because the installation of new rail was performed without re-gaging the plates, the measured track gage in both the cut spike and direct fixation fastening system zones can be attributed to long term degradation.

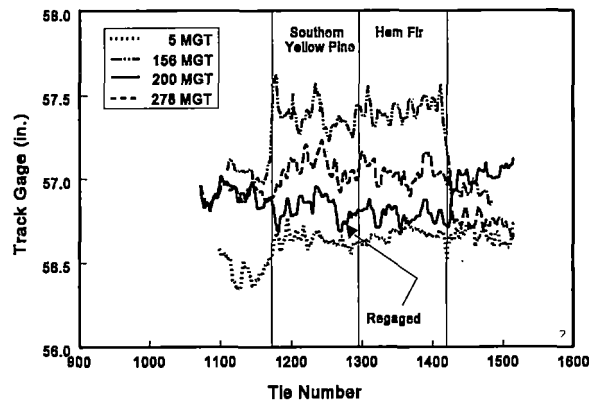
Figure 6. Accumulated Track Gage on the Southern Yellow Pine and Hem Fir Tie Sections

In Section 25, track gage degradation was also significant in the hem fir and southern yellow pine ties installed at the start of the second phase of the HAL program. After 200 MGT of HAL traffic, the ties gage widened significantly and required re-gaging. In fact gage widening was so severe the track supervisor felt that re-plugging and re-gaging the ties with the existing cut spike system would bring about gage widening in a short time period. Thus, the ties were re-gaged and equipped with Pandrol plates, fasteners, and coach screws in an attempt to lengthen the re-gaging maintenance cycle.

Figure 6 shows the measured track gage for the hem fir and southern yellow pine. The change in track gage between 156 and 200 MGT of accumulated HAL traffic once again was due to re-gaging prior to the 200 MGT measurement.

While Pandrol plates and coach screws improved gage retention of the ties, the coach screws were continually working out of the ties under traffic. In an attempt to remedy the problem, threaded coil inserts were used in the hold down hole. However the screws continued to work out wherever a split was present in the hold down hole. Tie splitting may have been too severe for this type of repair. The severe tie condition was accelerated by rail plugs installed during a period when rail fatigue caused numerous breaks.

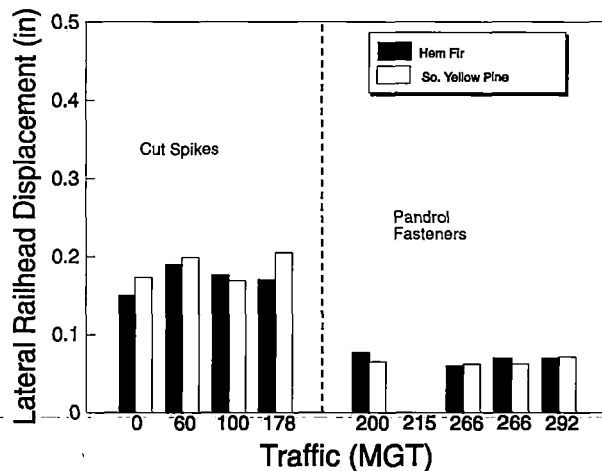
Figure 7. Lateral Railhead Displacement

Track strength, a measurement used to monitor tie and fastener degradation, is determined by statically applying known vertical and lateral loads to the rails, while measuring the lateral railhead and rail base displacement. In Figure 7, railhead displacement measured on the hem fir and southern yellow pine ties is shown. The data, under 40,000 vertical and 20,000 pounds static loads, indicates that gage restraint increased after the installation of the Pandrol fastening system. The measured average lateral railhead displacement was about 50 percent less.

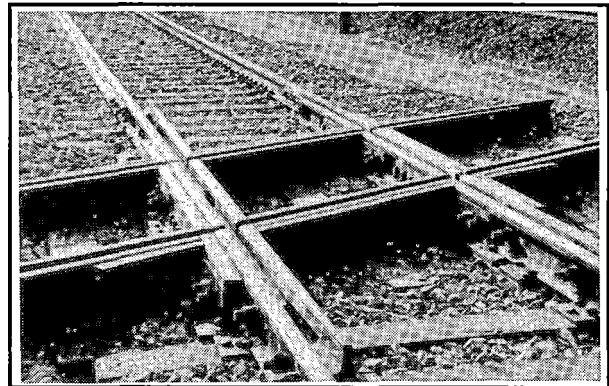
Figure 2. 62-Degree Three-Rail Bolted Crossing

The original 62-degree crossing (Figure 2) was subjected to 4.6 MGT of HAL traffic at FAST before being removed from track. The reason for removing the crossing from track was excessive damage to the rail ends at the gaps in the crossing. As might be expected, the rail ends downstream of the gap suffered the most severe damage after a day of train operation in one particular direction.

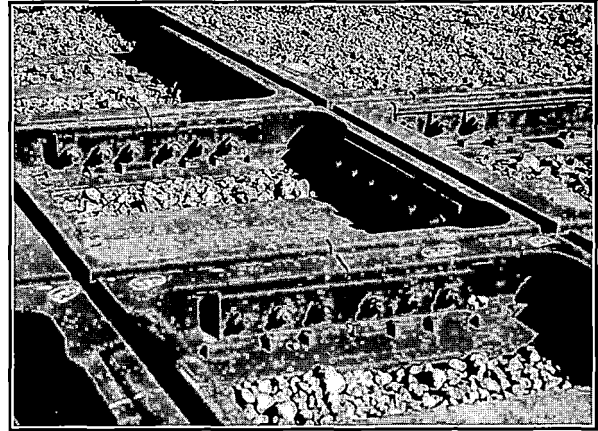
Figure 4. 76-Degree Solid Manganese Crossing

The 76-degree solid manganese crossing survived a total of 15.9 MGT of HAL traffic at FAST (Figure 4). After 10.8 MGT of traffic, the crossing was removed from track to repair a crack in one of the castings. After the repair, the crossing was reinstalled and withstood an additional 5.1 MGT of HAL traffic. It was removed again due to additional cracks in the same casting. The new cracks were not in the repair welds or the associated heat affected zones.

During the first 10.8 MGT of service, the ballast beneath the crossing was hand tamped every 1 to 3 MGT. The ballast contained a high percentage of slag, which appeared to deteriorate rapidly beneath the crossing. When the crossing was reinstalled, after the casting repair, granite ballast was used to minimize track surface problems.

Aside from the out-of-track repair of the cracked casting, the crossing also required in-track maintenance. The gage corners of the running surface were ground lightly every 2 to 3 MGT to remove metal flow and maintain flangeway clearance. No build-up welding was performed during the first 10.8 MGT, although the batter was about 1/4 inch at each of the flangeway gaps. The battered ends were built up in conjunction with the casting repair. Other portions of the running surface performed well, with no corrugations or batter after 15.9 MGT of HAL traffic. During this period, eight of the torque-stud bolts came loose and were retightened using a conventional track wrench.

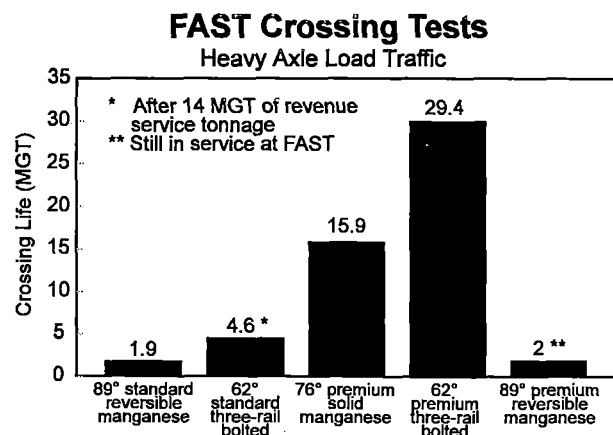
Figure 6. Life of Various Crossing Under HAL Traffic at FAST

Figure 6 shows the total HAL tonnage carried by each of the crossings installed at FAST.

The crossing hardness failure mode is an issue worth noting. Failure of the rebuilt 62-degree crossing with head hardened rail was due to a head-web separation crack at one of the flangeway gaps. This type of crack is not easily detected and can lead to a catastrophic railhead failure with little prior visible signs of distress. In all the other crossing failures,

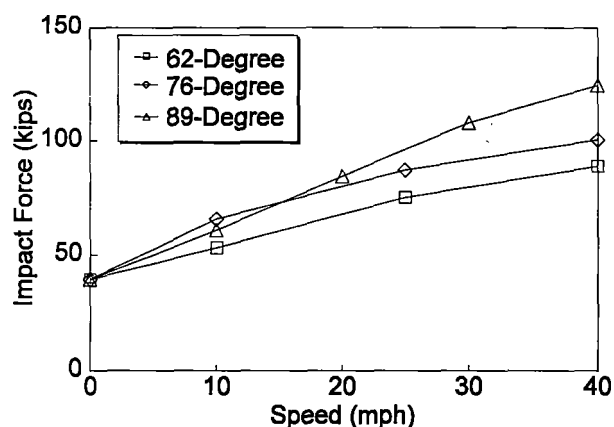
Figure 7. Average Crossing Impact Forces under HAL Cars

Instrumented wheel sets were used to measure impact forces in several of the crossings due to 100-ton cars and HAL cars at various speeds. Figure 7 summarizes the wheel impact force data for HAL (315,000 lb) cars. Similarly, Figure 8 summarizes the impact force data for 100-ton (263,000 lb) cars. For each crossing, the impact forces increased with increasing speed. Each data point represents the average of at least 16 impact measurements. At zero speed, the static wheel loads are plotted. The test trains used to perform these measurements ran over the crossings at speeds from 10 to 40 mph in both directions for each speed. The instrumented

The higher the crossing angle, the greater the increase in wheel impact force with increasing speed. The impact forces generally increase linearly with speed through 40 mph. The nonlinearity in the responses for the 76-degree crossing may be due to the fact that the measurements were taken just after the completion of the repair and build-up welding on the casting material.

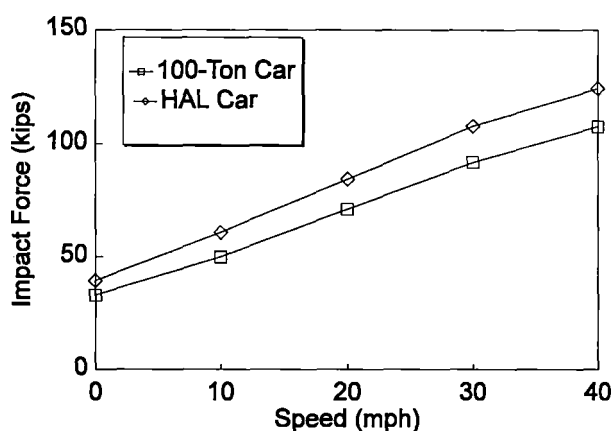
Figure 9. Average Impact Forces on 89-Degree Crossing

Figure 9 shows a comparison of the wheel impact forces in the 89-degree crossing due to HAL and 100-ton cars. The HAL car produced impacts that were about equal to those for a 5 to 10 mph higher speed with the 100-ton car. At 40 mph, the average impacts are more than three times the static wheel load for both cars.

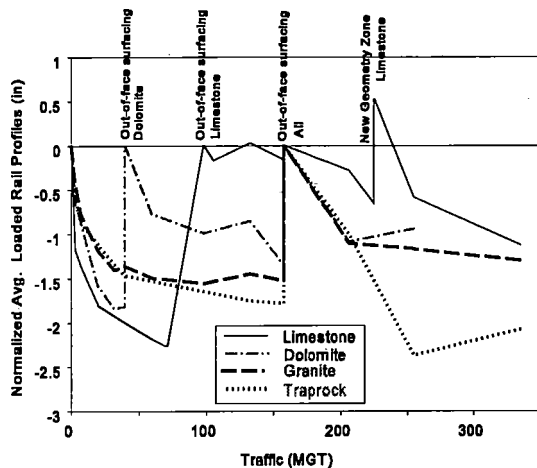
Figure 4. Loaded Profile Settlement — High Rail

The traprock and granite ballasts experienced less settlement than the dolomite and limestone ballasts during the first 160

MGT of HAL traffic. A substantial increase in track settlement is evident in the traprock ballast after the out-of-face surfacing at 160 MGT. The surfacing resulted from rail changes in part of Section 03. Performing the out-of-face surfacing cycle on the traprock, when it did not require it, appears to have had a detrimental effect on the ballast.

When track settlement occurs, surface problems are not necessarily the outcome. However, if this settlement between the two rails is uneven, and/or profile deviations occur, maintenance requirement may increase. The maintenance required in both the dolomite and limestone ballast was due to uneven settlement between the two rails. The measured settlement was about 50 to 60 percent more on the high rail.

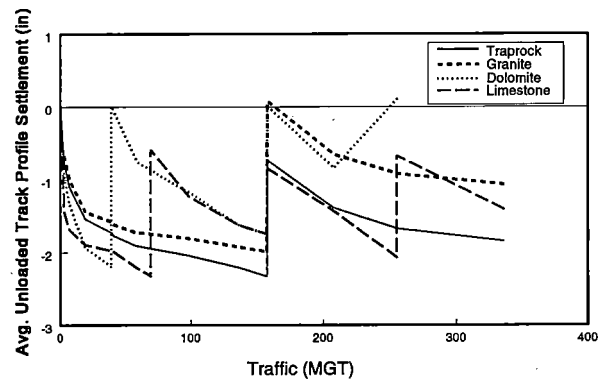
Figure 5. Average Unloaded Track Profile — High Rail

The unloaded track profile elevations in Figure 5 show an initial large settlement rate during the first 50 MGT of traffic. However, the settlement rate leveled off after the first 50 MGT.

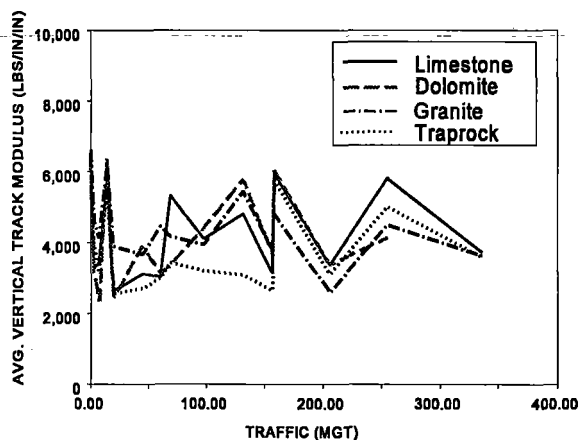
Figure 7. Average Vertical Track Modulus — High Rail

Data from the track modulus measurements reflect no major difference between the ballast materials in test. There appears to be a greater variation in track modulus with tonnage. Conditions that may have caused this change are surfacing operations and frozen ballast conditions. Some of the data

was collected during the winter months, and during surfacing operations. The changes in modulus after the surfacing operations are clearly evident. The dolomite was surfaced out-of-face at 40 and 160 MGT, the limestone was surfaced at 70, 160, and 225 MGT, while the granite and traprock were surfaced at 160 MGT.

Figure 7 shows the average track modulus values for the high rail. The ranges for both the low and high rail were between 3,000 and 4,000 lb/in/in.
